Comparative Evaluation of the Effect of Chamfer and Shoulder on the Fracture Resistance of all Ceramic Restorations: An in Vitro Study (Chamfer vs Shoulder)

Keywords: Chamfer; Shoulder; Fracture resistance; all ceramic; Inceram.

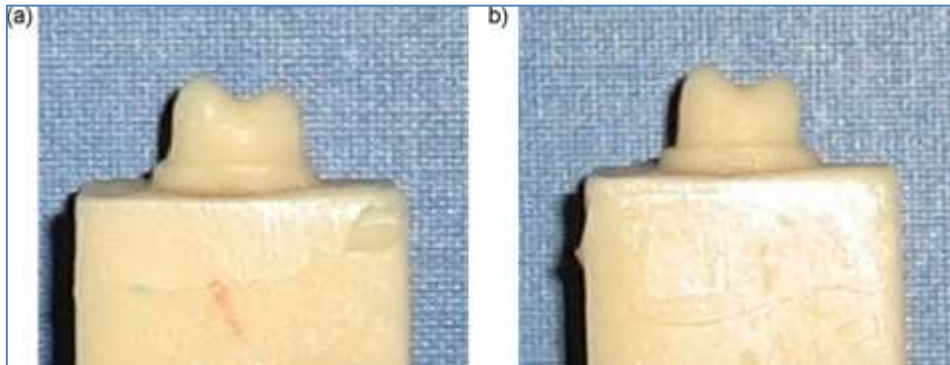
Fig-3: Impressions from the first maxillary premolar with 50 in. chamfer margin were poured with epoxy resin and make epoxy resin dies with chamfer margin (a) impressions with 90 in. shoulder margin were poured with epoxy resin and make epoxy resin dies with shoulder margin (b)

Italy). The impressions were poured using Epoxy resin CW2215 (Hunstman, Germany) [17] to create ten identical resin dies with a 50 in. chamfer margin (Fig. 3). Afterwards, the tooth was retrieved and the 50 in. chamfer was converted into a 90 in. shoulder using a cylindrical diamond bur (1 mm depth) [14, 15] (Fig. 2). Again 10 polyvinylsiloxane impressions were made and ten epoxy resin dies were created from these impressions (Fig. 3).

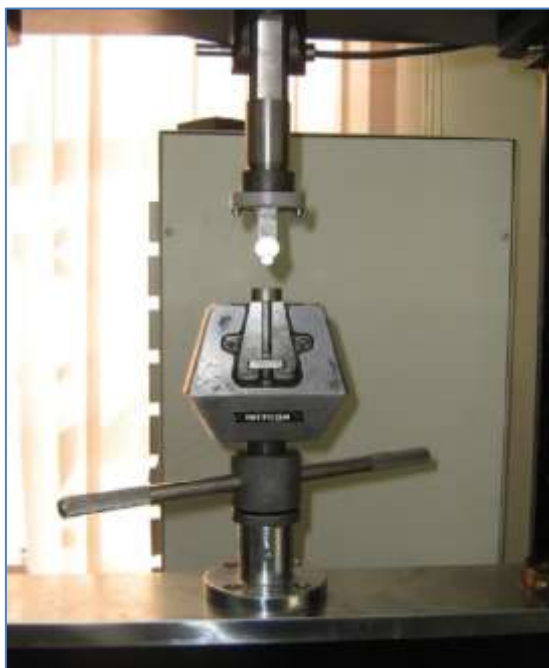
Fig-4: Universal testing machine (instron) with 5 mm diameter stainless steel ball using for applying load on the alumina cores

Mechanical tests were carried out using a universal testing machine (Instron). Each specimen underwent a load with a minimal load of 5N with a 5 mm diameter stainless steel ball (Fig. 4). The load was applied at the center of the occlusal surface

along the long axis with a crosshead speed of 1 mm/min until fracture occurred [20]. The fracture load data were automatically recorded using Nexigion software. Samples were investigated from the point of view and stereomicroscope of the origin of the failure (Fig. 5).

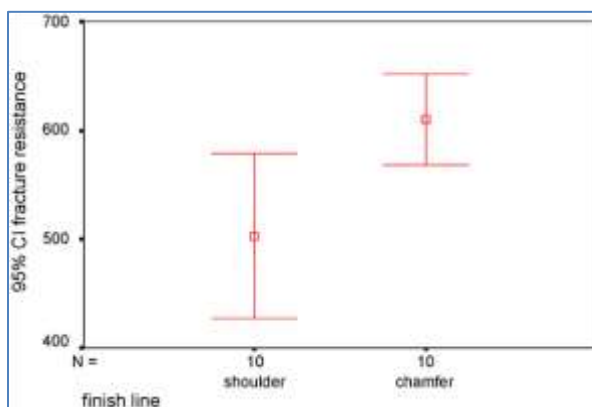
Error-bar graph shows the mean fracture resistance of shoulder margin and chamfer margin with 95% confidence interval (Fig. 6, graph).

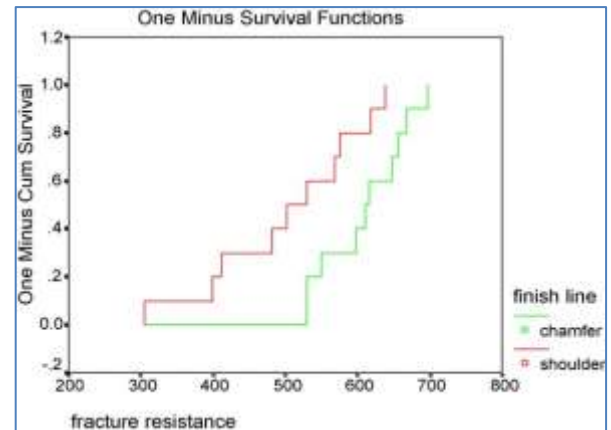
Fig-7: Graph: Kaplan-Meier, survival analysis for fracture resistance in the 2 Finishing line

Coefficient Of variation (SD/mean = CV) in shoulder margin is more than chamfer margin. Kaplan-Meir graph shows the cumulative distribution of fracture/load in the chamfer and shoulder finishing lines (Fig. 7, graph).
